SUBJ: EPA Asbestos Removal at 303 Houston Street

REMOVAL ACTION STATUS REPORT DAVIDSON ASBESTOS

Property Address: 303 Houston Street, Davidson, Mecklenburg County, North Carolina

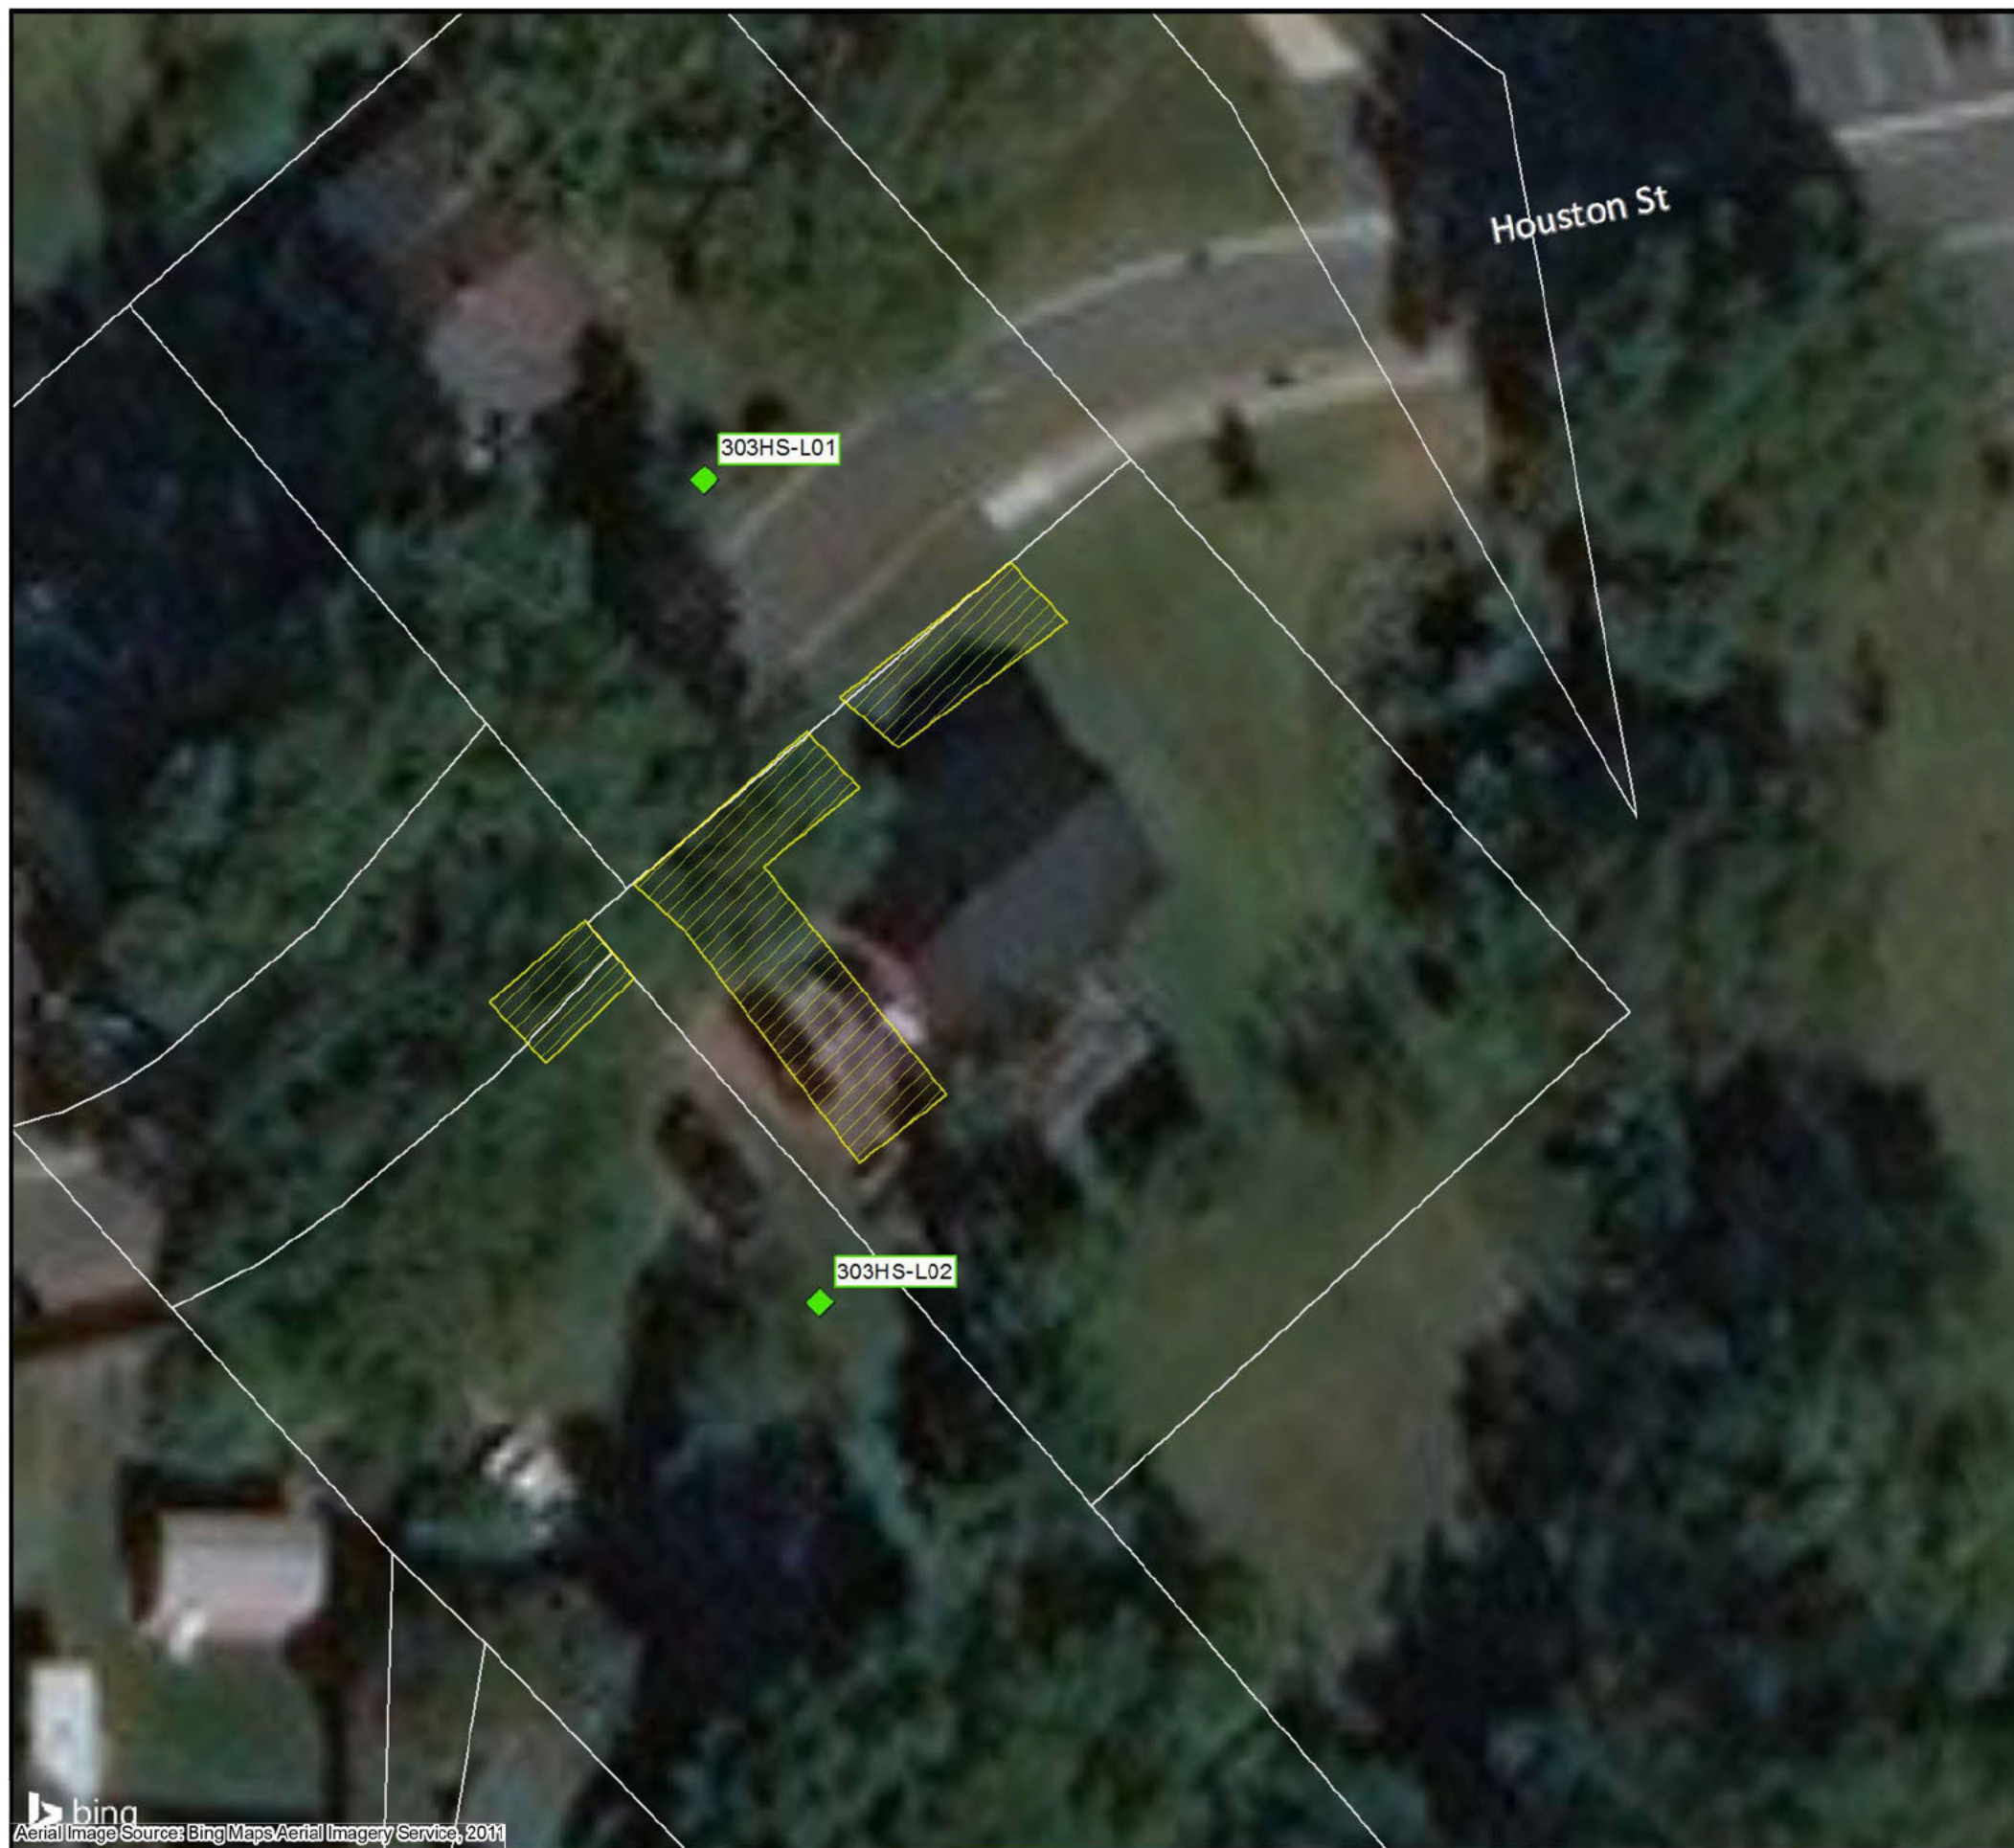
FIGURE 1

Description of Removal Action: The soil was excavated to an approximate maximum depth in the following areas: portions of the front yard and driveway along Houston Street to 12 inches; tree line area along Houston Street and residential drip lines to 2 inches; and, the western side of the residence to 3 inches (see Appendix 1). Visual inspections of the areas excavated for asbestos-containing materials (ACM) were conducted by a State of North Carolina-accredited asbestos inspector and air monitor. Additional removal was conducted in those areas where ACM were still visibly present. Once ACM was no longer visibly present, restoration of the excavated areas was allowed to commence.

Removal Areas and
Air Sampling Locations

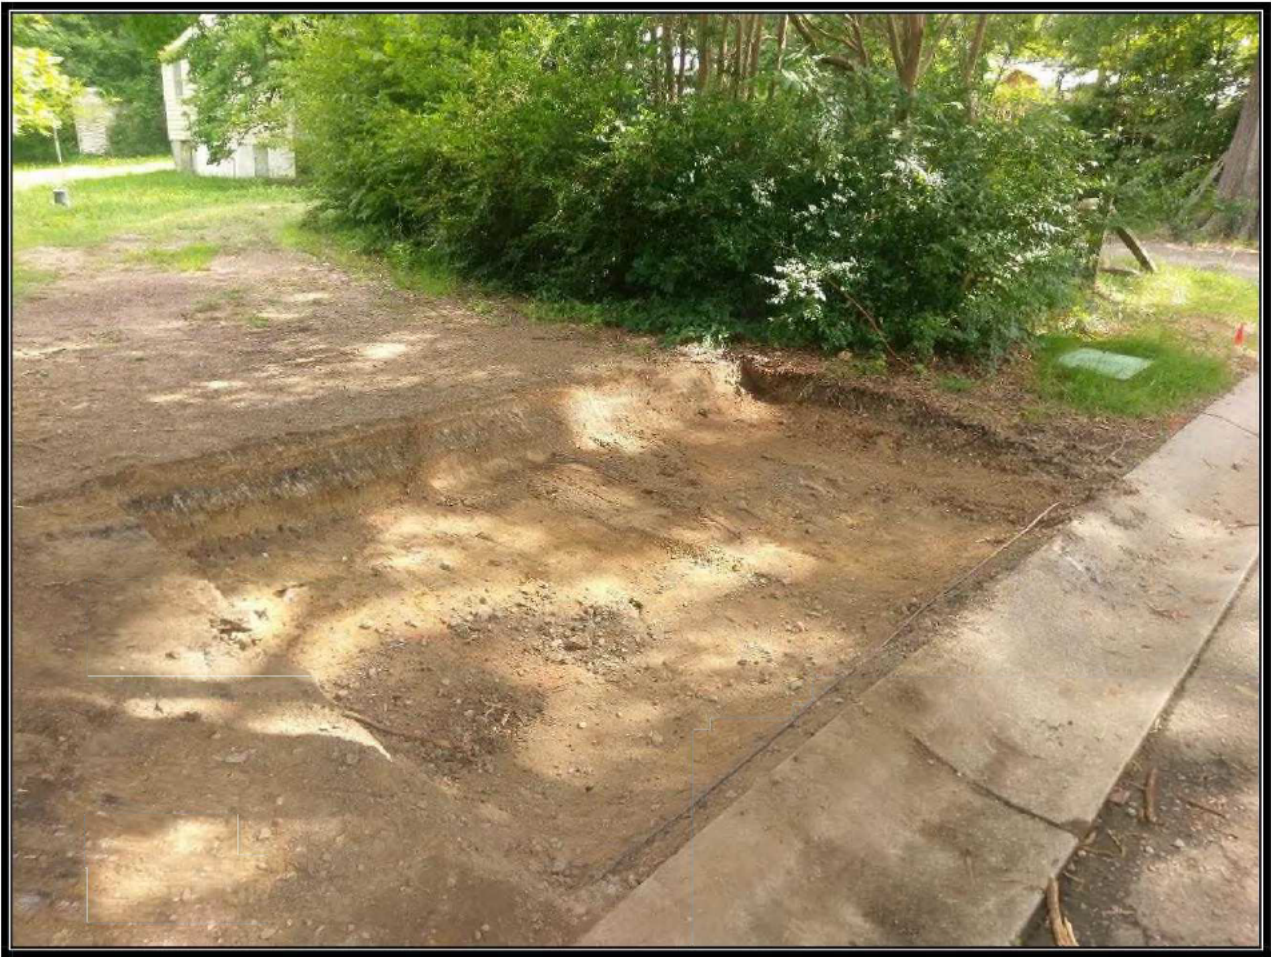
OFFICIAL PHOTOGRAPH NO. 1
U.S. ENVIRONMENTAL PROTECTION AGENCY

Subject: The Emergency and Rapid Response Services (ERRS) contractor, Environmental Restoration, LLC (ER), used an excavator and hand tools to remove asbestos-containing materials (ACM) and asbestos-contaminated soil from the driveway located at 303 Houston Street. ER used hoses to wet the asbestos-contaminated soil during removal activities.

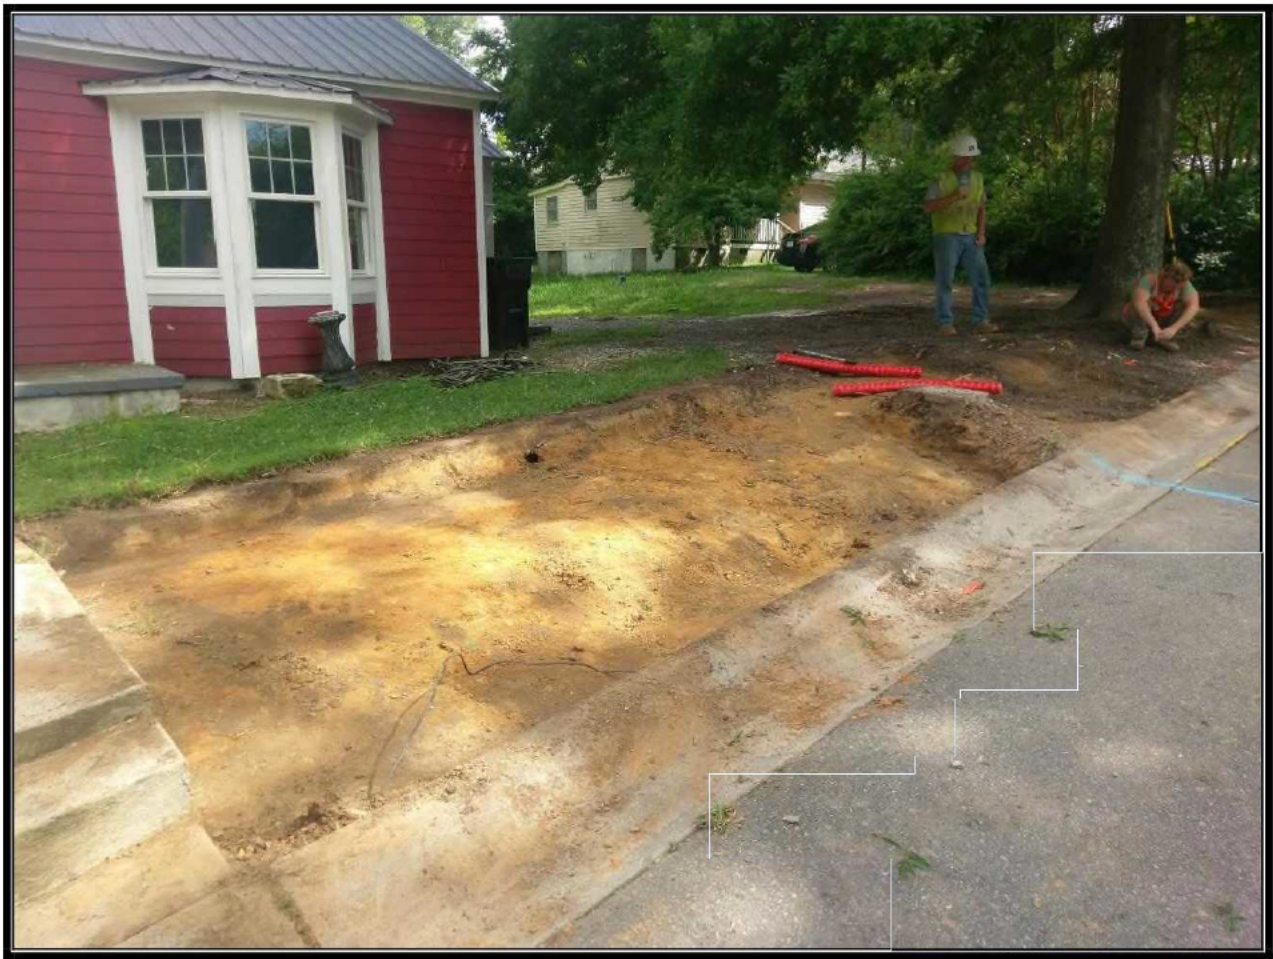
OFFICIAL PHOTOGRAPH NO. 2
U.S. ENVIRONMENTAL PROTECTION AGENCY

Subject: ER used an excavator and hand tools to remove ACM and asbestos-contaminated soil from the front yard located at 303 Houston Street. ER used hoses to wet the asbestos-contaminated soil during removal activities.

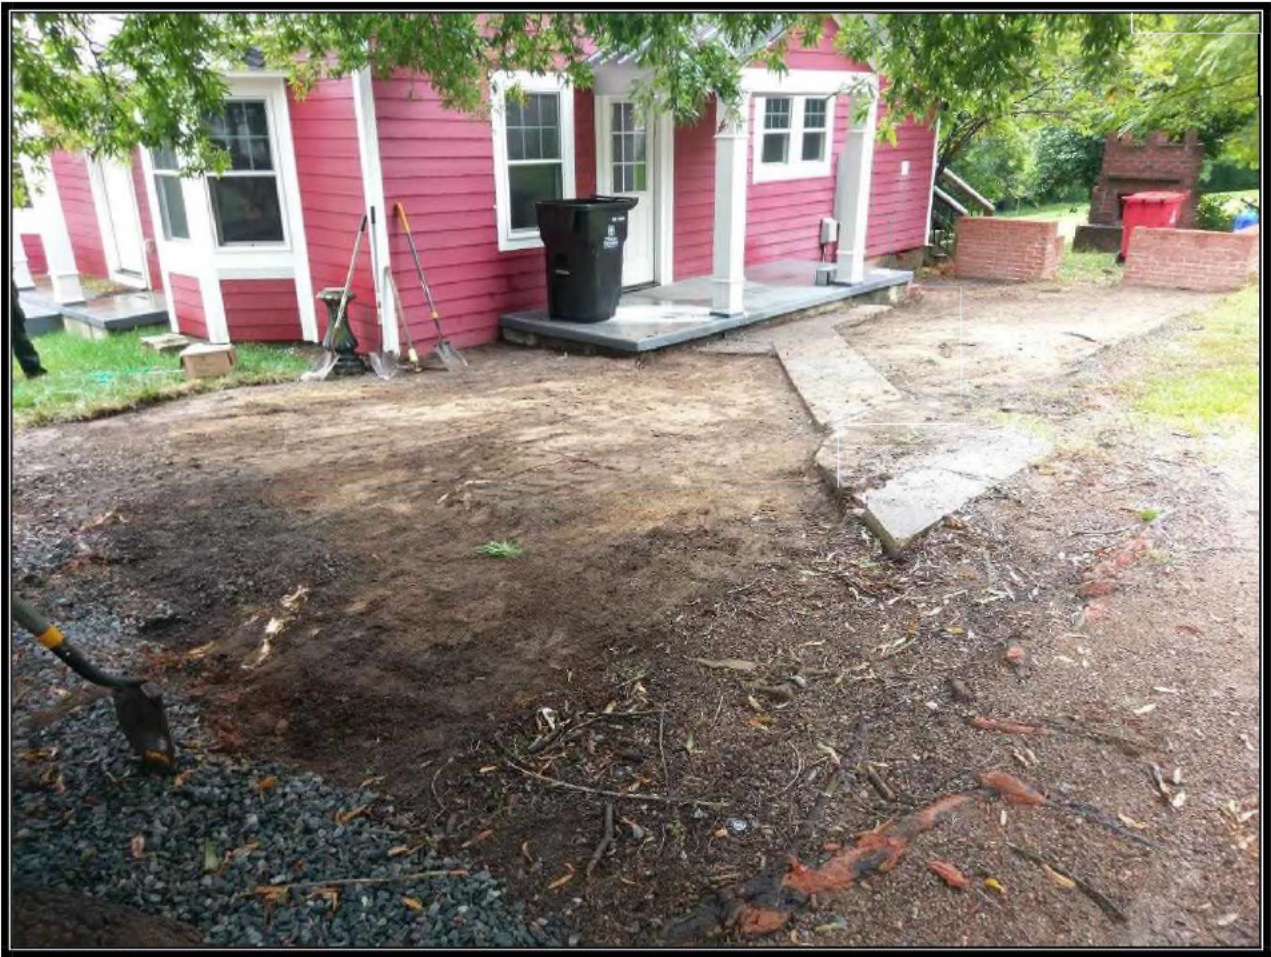
OFFICIAL PHOTOGRAPH NO. 3
U.S. ENVIRONMENTAL PROTECTION AGENCY

Subject: ER used an excavator and hand tools to remove ACM and asbestos-contaminated soil from the western side of the property located at 303 Houston Street. ER used hoses to wet the asbestos-contaminated soil during removal activities.

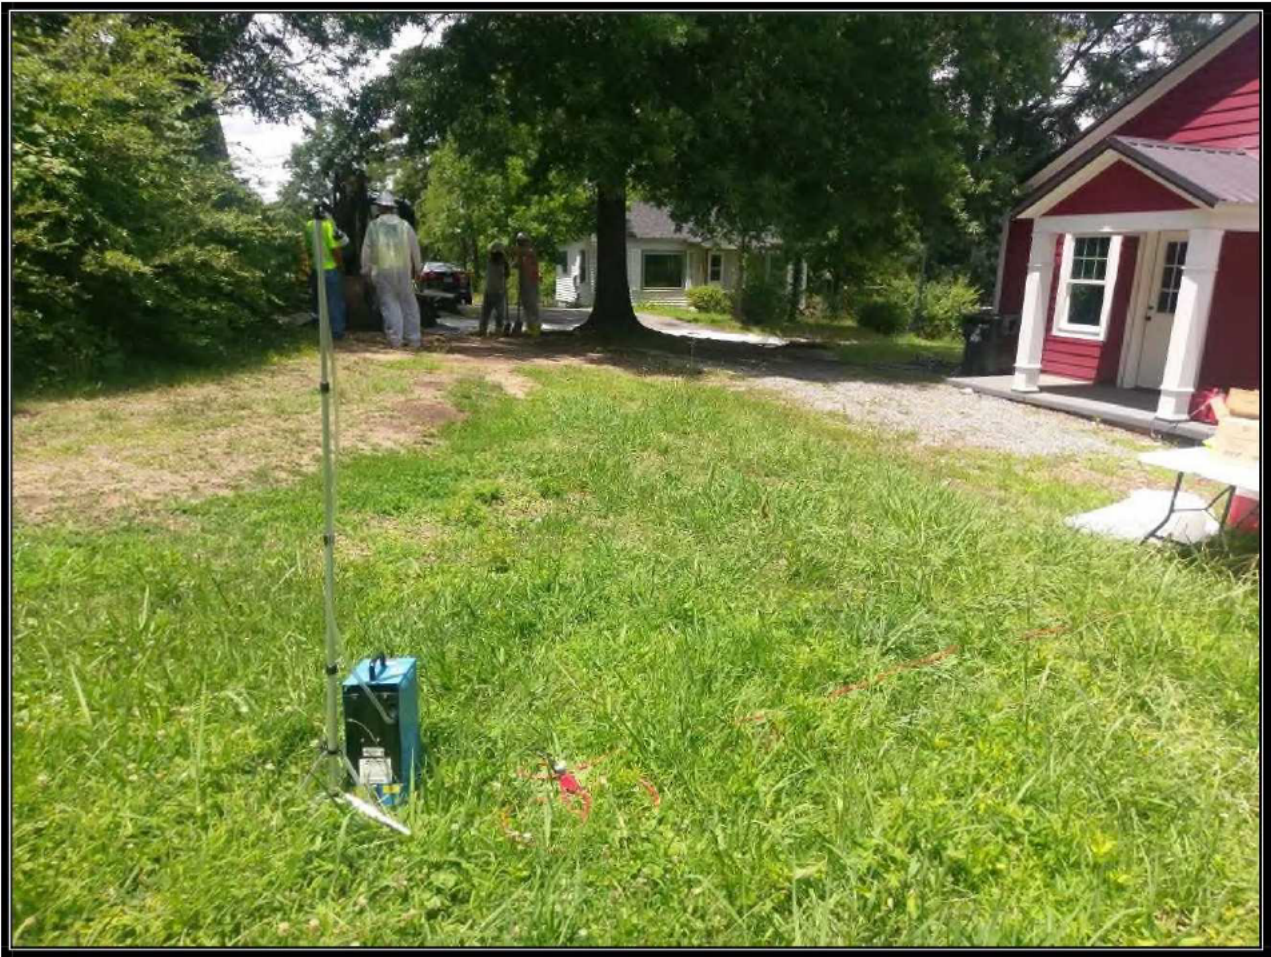
OFFICIAL PHOTOGRAPH NO. 4
U.S. ENVIRONMENTAL PROTECTION AGENCY

Subject: Perimeter air sampling was conducted by a Tetra Tech Superfund Technical Assessment and Response Team (START), State of North Carolina-accredited air monitor, to evaluate the effectiveness of engineering and safety controls in preventing the off-site migration of asbestos fibers during removal activities.

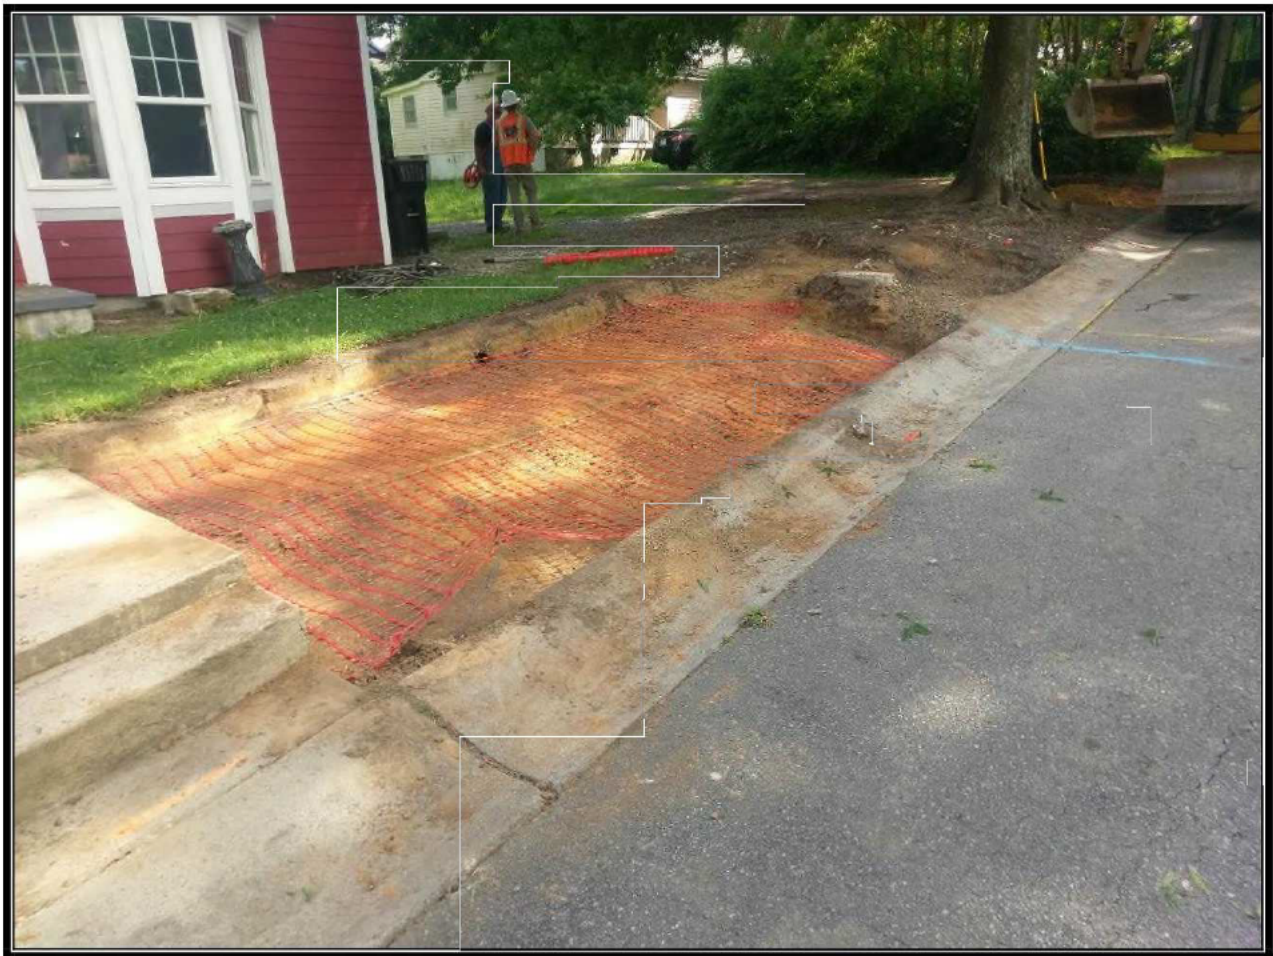
OFFICIAL PHOTOGRAPH NO. 5
U.S. ENVIRONMENTAL PROTECTION AGENCY

Subject: ER installed snow fencing along the subsurface of the excavated front yard and driveway areas after the visual inspection conducted by Tetra Tech START, State of North Carolina-accredited asbestos inspector and air monitor, resulted in no visible ACM in the excavated area.

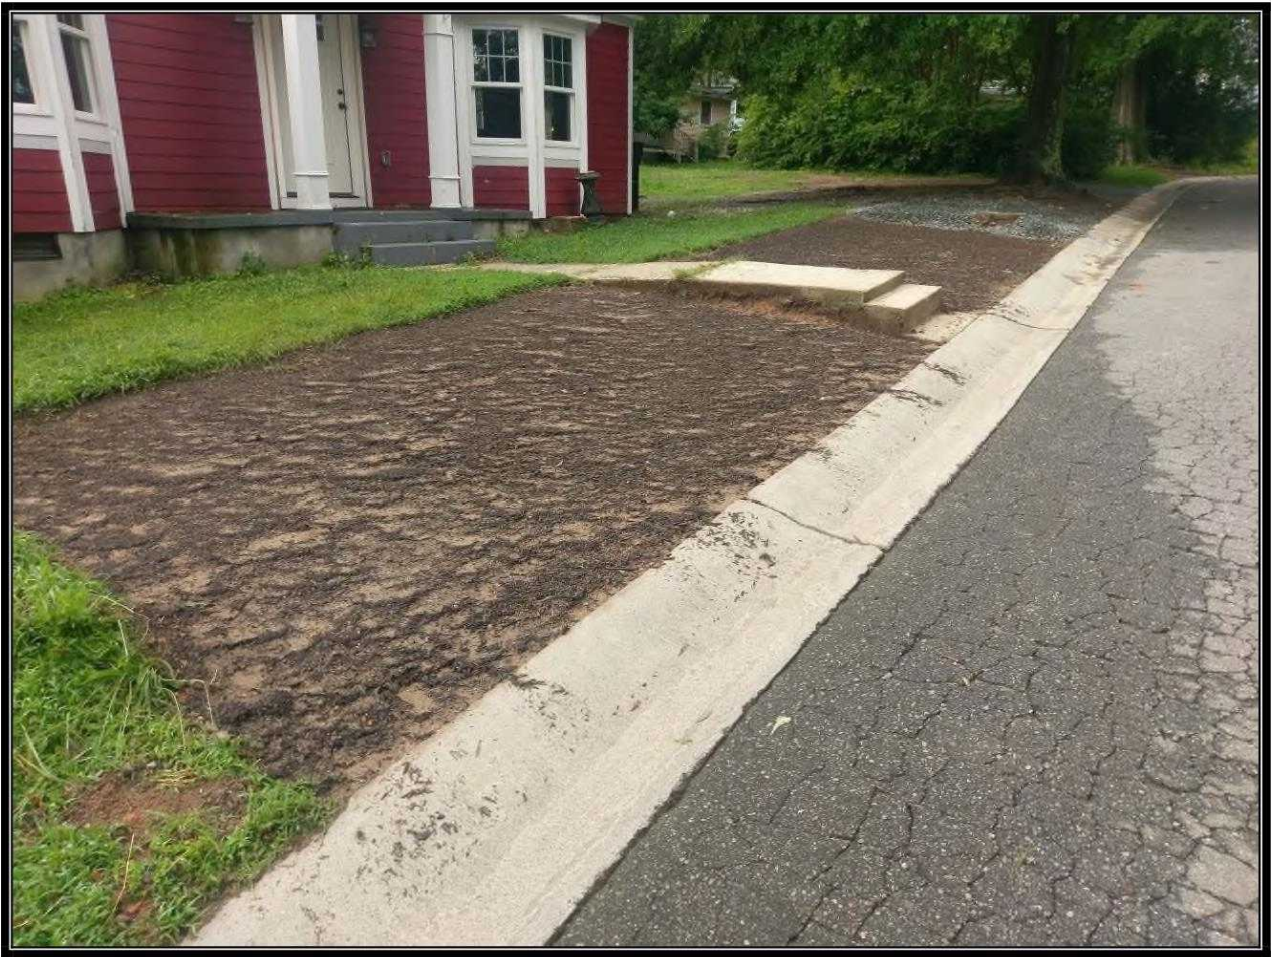
OFFICIAL PHOTOGRAPH NO. 6
U.S. ENVIRONMENTAL PROTECTION AGENCY

Subject: ER used dump trucks, skid steers, and hand tools to install topsoil in the excavated front yard area and rock around the tree line.

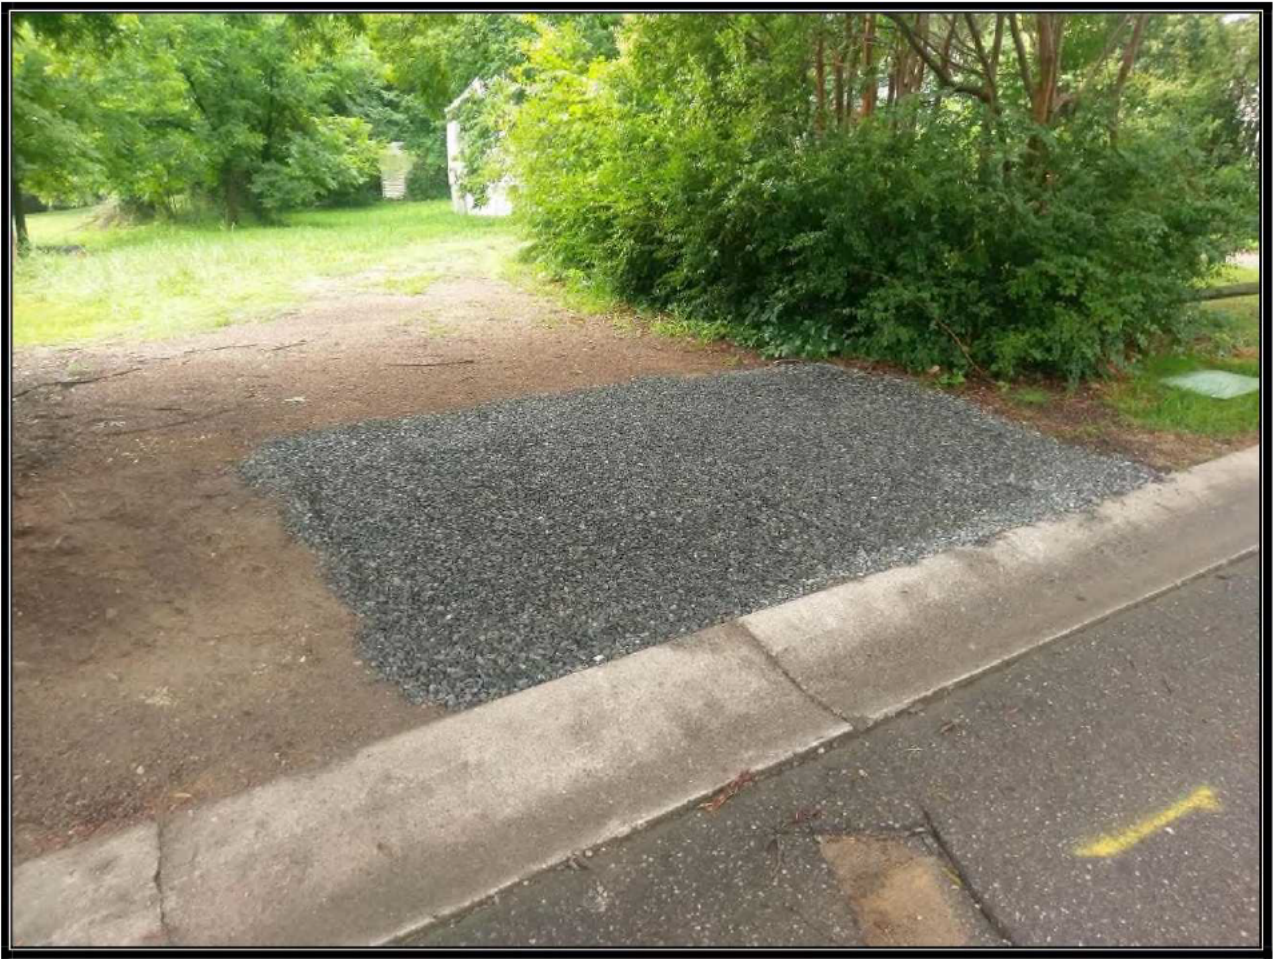
OFFICIAL PHOTOGRAPH NO. 7
U.S. ENVIRONMENTAL PROTECTION AGENCY

TDD Number:	TT-01-071	Location:	Davidson Asbestos
Orientation:	Southeast	Date:	June 20, 2017
Photographer:	Paul Prys, Tetra Tech	Witness:	None
Subject:	ER used dump trucks and skid steers to install rock in the excavated driveway.

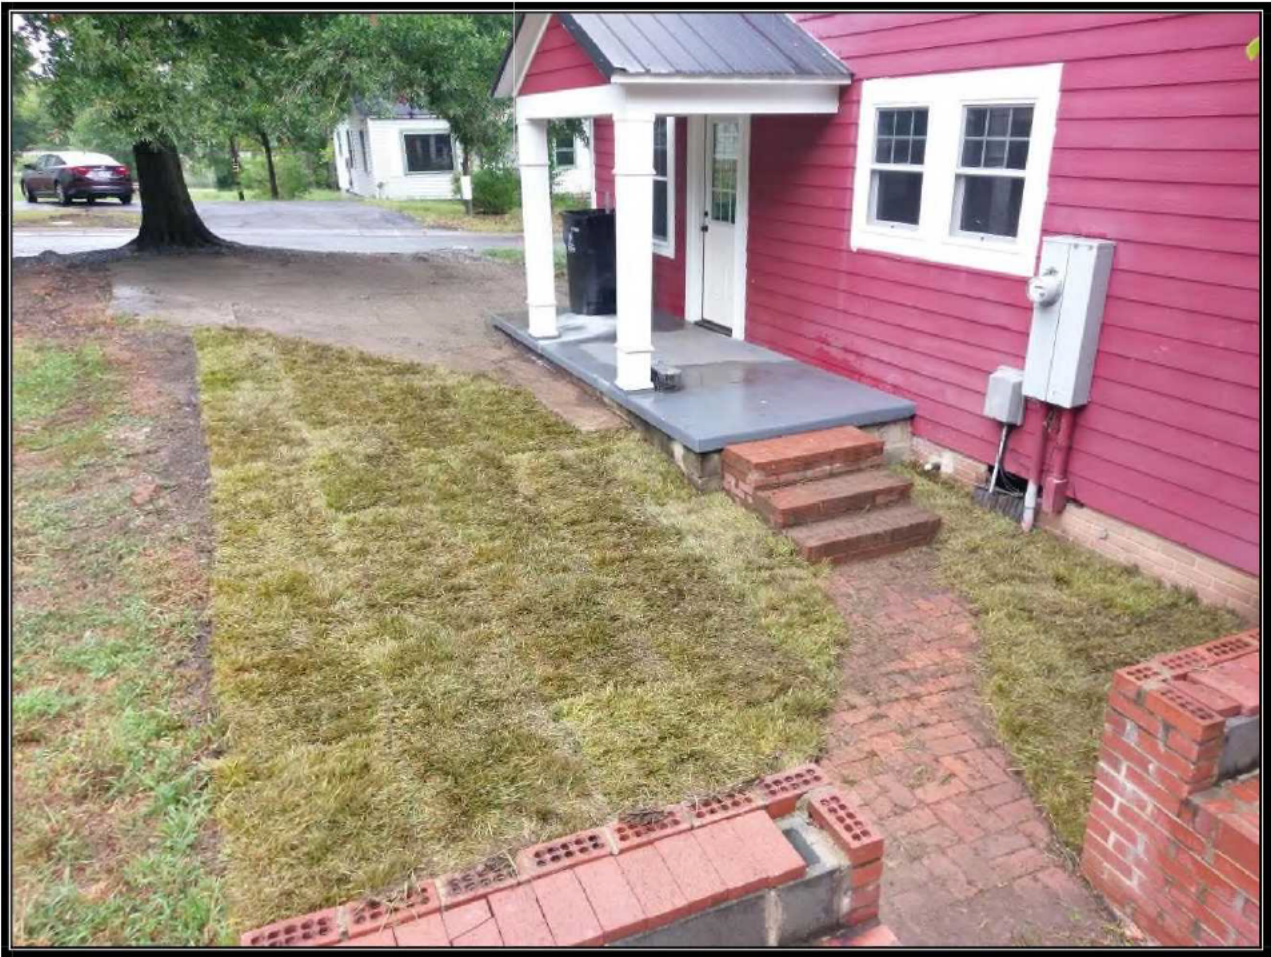
OFFICIAL PHOTOGRAPH NO. 8
U.S. ENVIRONMENTAL PROTECTION AGENCY

Subject: ER installed rock in the northern portion of and topsoil and sod in the southern portion of the western side of the residence after the visual inspection conducted by Tetra Tech. START, State of North Carolina-accredited asbestos inspector and air monitor, detected no visible ACM in the excavated area.
